ABBREVIATED SAFETY STUDY ERIE COUNTY, US 6, SLM 4.26-4.50

**OHIO DEPARTMENT OF TRANSPORTATION - DISTRICT 3
2015 MOTORCYCLE CRASH LOCATION
NO. 16**

*Anthony DePrator, E.I.T., MSCE
Transportation Engineer
(419) 207-7167
anthony.deprator@dot.ohio.gov
July 2017*

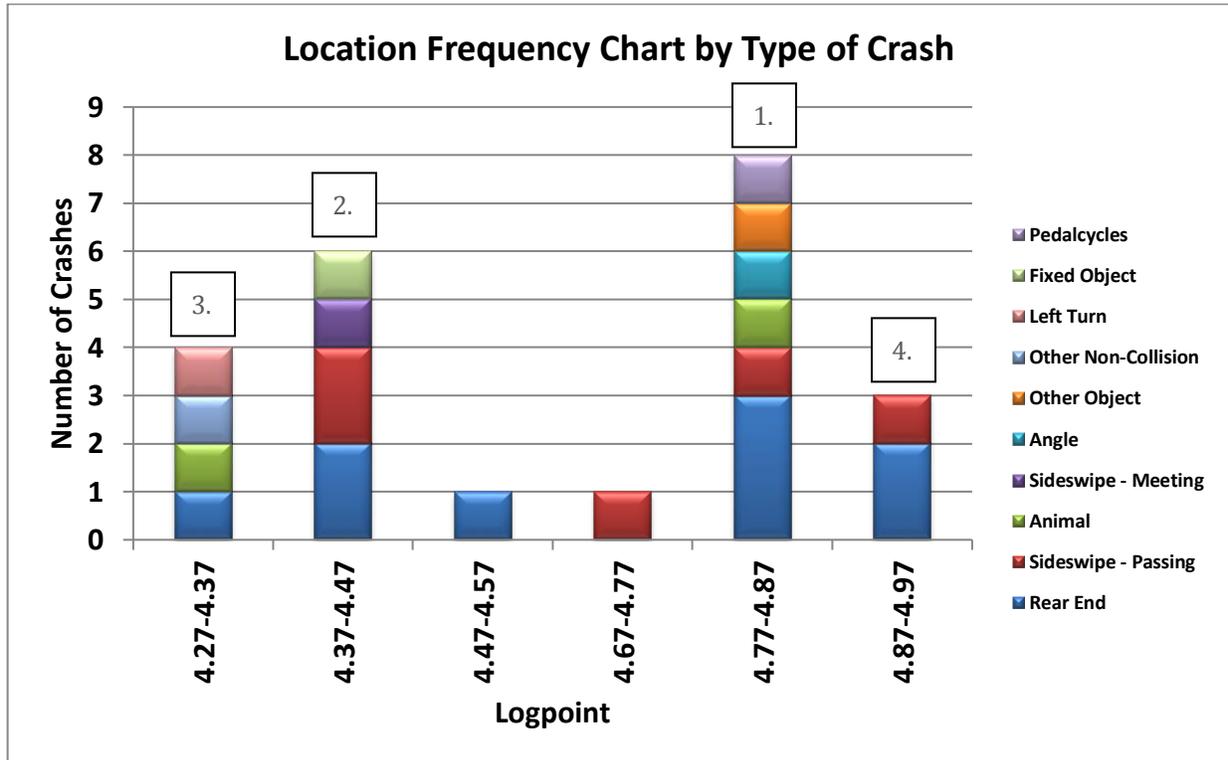
FIGURE 2: CRASH LOCATION VS. FREQUENCY BY TYPE

Crash data indicated a trend in congestion related crashes, the most frequent crash type being rear-end crashes and the second most frequent being sideswipe-passing crashes where motorists have illegally passed left turning vehicles using the available shoulder.

The number of crashes and type of those crashes were plotted by location in **Figure 2**. Most frequent to least frequent crash locations are as follows: 1. the intersection of US-6 and Thorpe Drive, 2. the intersection of

Fremont Avenue and Venice Road with US-6, 3. US-6 fronting “Sandusky Food & Wine” and “The Original Margaritaville”, and 4. the intersection of US-6 with Cold Creek Boulevard.

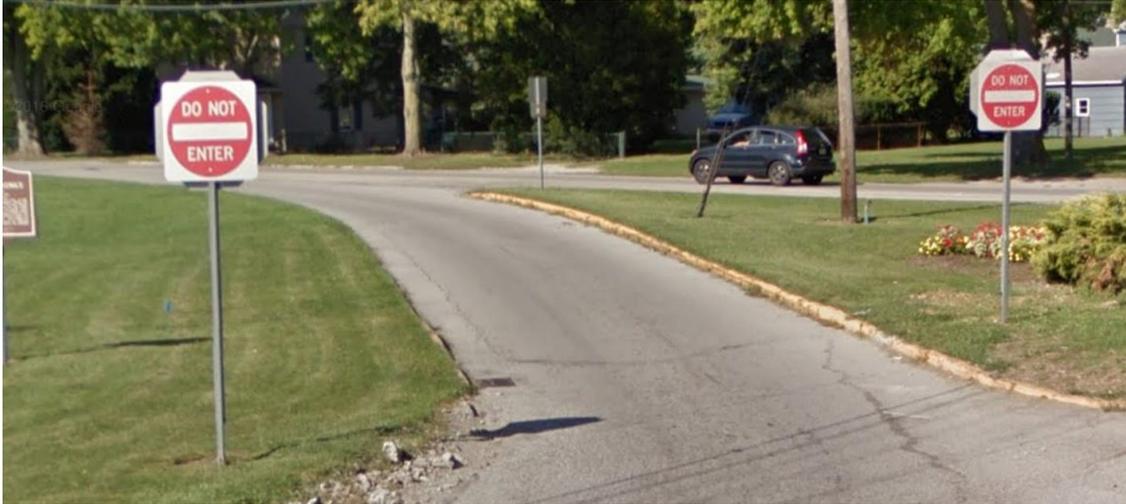
FIGURE 3: STOP SIGNS ON CHANNELIZED RIGHT TURN

1. 7/31/2013: A 50 year old male was stopped in the eastbound channelized right turn lane on US-6 at the intersection of Venice Road and Fremont Avenue where he misinterpreted the intersection as all-way stop control. He began to pull from the stop-bar, but then stopped, yielding to eastbound traffic on Venice Road approaching the intersection. A 49 year old female in a motorcycle behind him, failing to see that the motorcycle in front of her stopped, then caused a collision between the two vehicles. Both drivers were from Pennsylvania.

1. *Increase Stop Sign Size:* It is recommended that the stop signs at the intersection of Venice Road and Fremont Avenue be increased in size. With the shape of the stop sign obscured, it is difficult for motorists on other approaches to discern when traffic must yield the right-of-way. Further guidance can be found in OMUTCD.2B.10.08. The site in question can be found shown in **Figure 3**.

3. *Stop Bar Installation:* It is recommended, to reinforce the stop control of vehicles along the corridor, that stop bars be installed, again as shown in **Figure 3**. If reconfigured, the installation of yield lines, commonly referred to as “Shark’s Teeth”, is also recommended. Further information on this topic can be found in OMUTCD.3B.16.

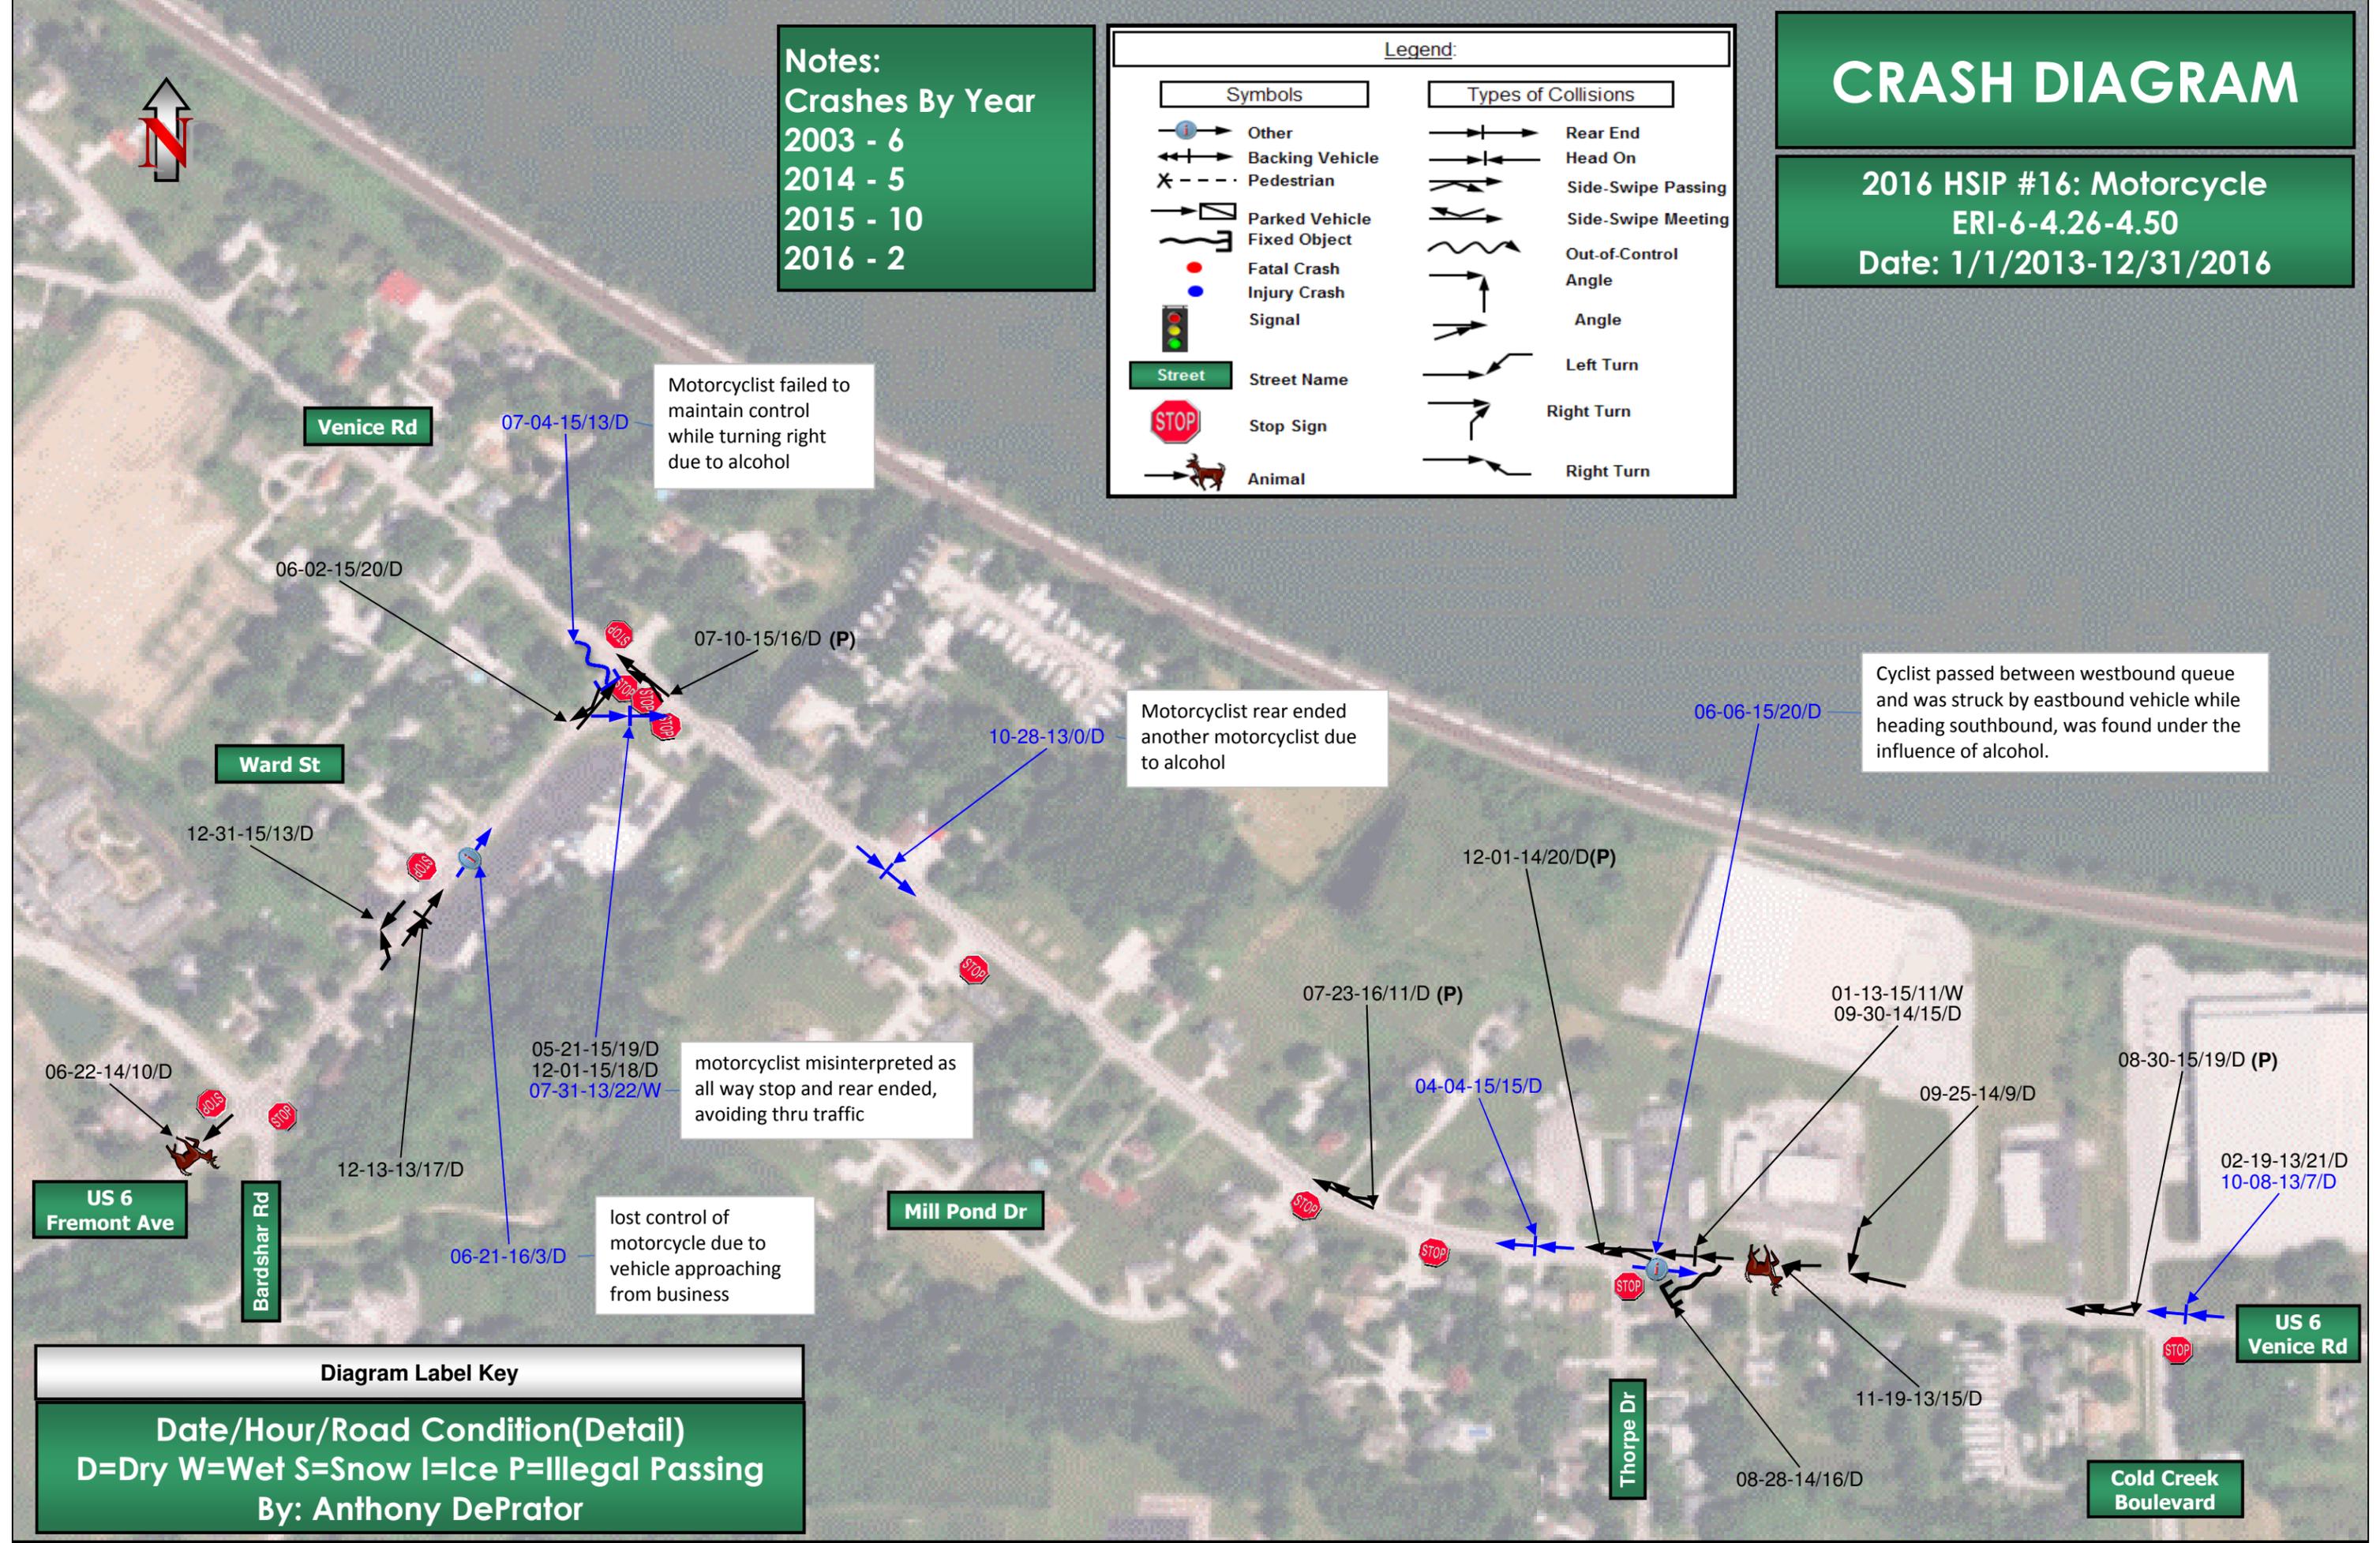
APPENDIX A: CRASH DIAGRAM

Motorcyclist failed to maintain control while turning right due to alcohol

Motorcyclist rear ended another motorcyclist due to alcohol

Cyclist passed between westbound queue and was struck by eastbound vehicle while heading southbound, was found under the influence of alcohol.

motorcyclist misinterpreted as all way stop and rear ended, avoiding thru traffic

lost control of motorcycle due to vehicle approaching from business
